Sudden downshift mechanism

**NHTSA Sudden Down Shift Investigation
BGFA-1018720 Low Temperature**

**BGFA-1018818 Sudden Down Shift Investigation
Low Temperature Mode**

**B7WA-8014113 Sudden Down Shift Investigation
Low Temperature Mode**

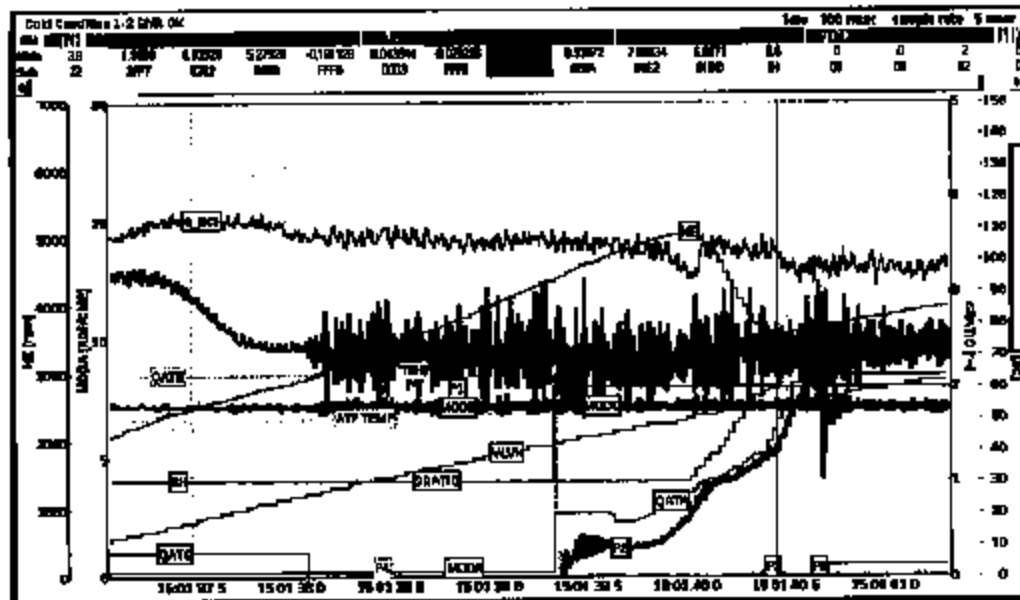
BGFA-1018720 1-2 Shift Cold Condition (53C)

Line Pressure, 1st Clutch and 2nd Clutch Pressure are Ok. (The cause of fluctuations in line pressure is due to noise.)

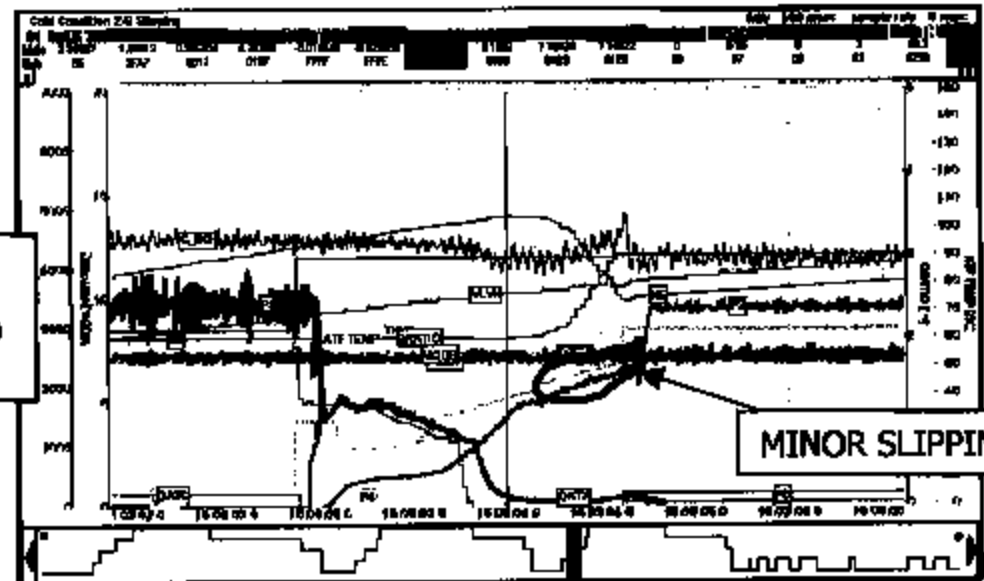
BGFA-1018720 2-3 Shift Cold Condition (60C)

Minor slipping found in 3rd Gear on 2-3 up shift.

MINOR SLIPPING

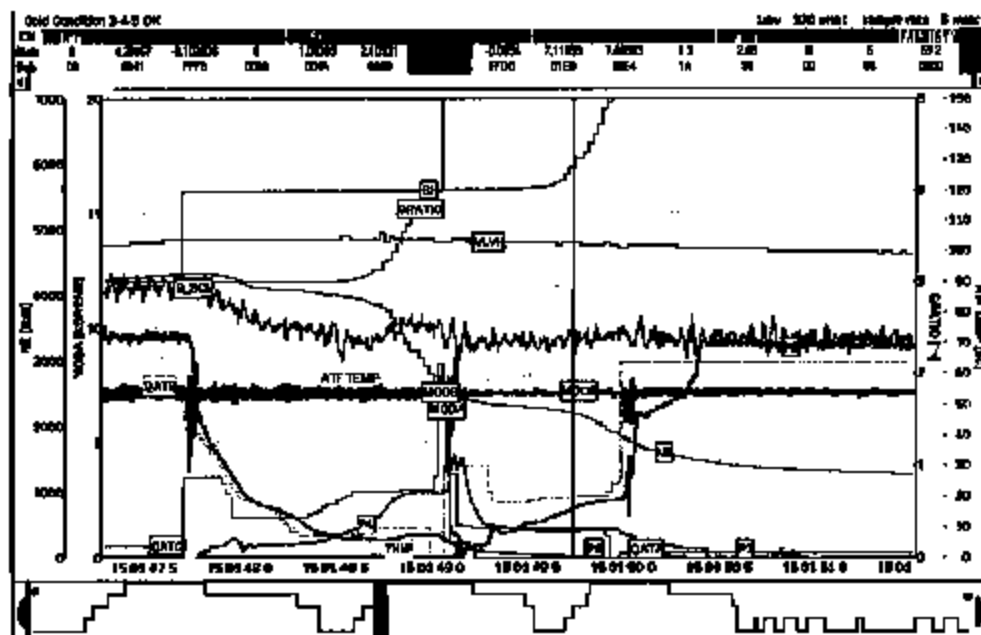
BGFA-1018720 2-3 Shift Cold Condition (59C)

3-4-5 shift ok, pressures ok.

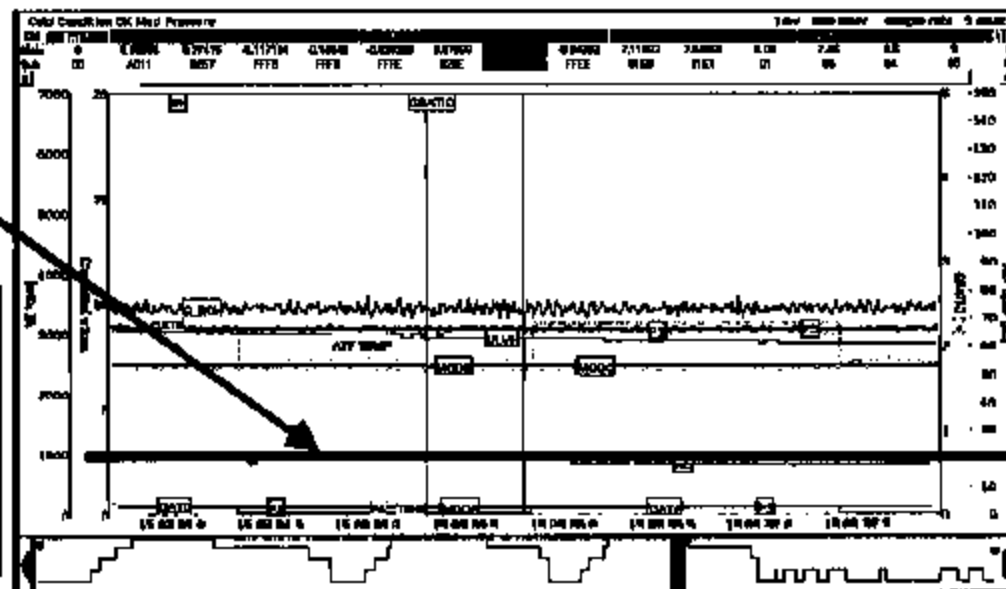
BGFA-1018720 5th cruise Cold Condition (TH off , 60C)

MOD Pressure Failure Point;
Where mod pressure is
overcome by shift valve C spring
pressure.

Sudden down shift didn't happen.
Modulator pressure did not fall below (2 KGF/Cm²).
So sudden down shift is not a possibility on this
transmission. Modulator pressure was below
normal but able to overcome spring pressure.

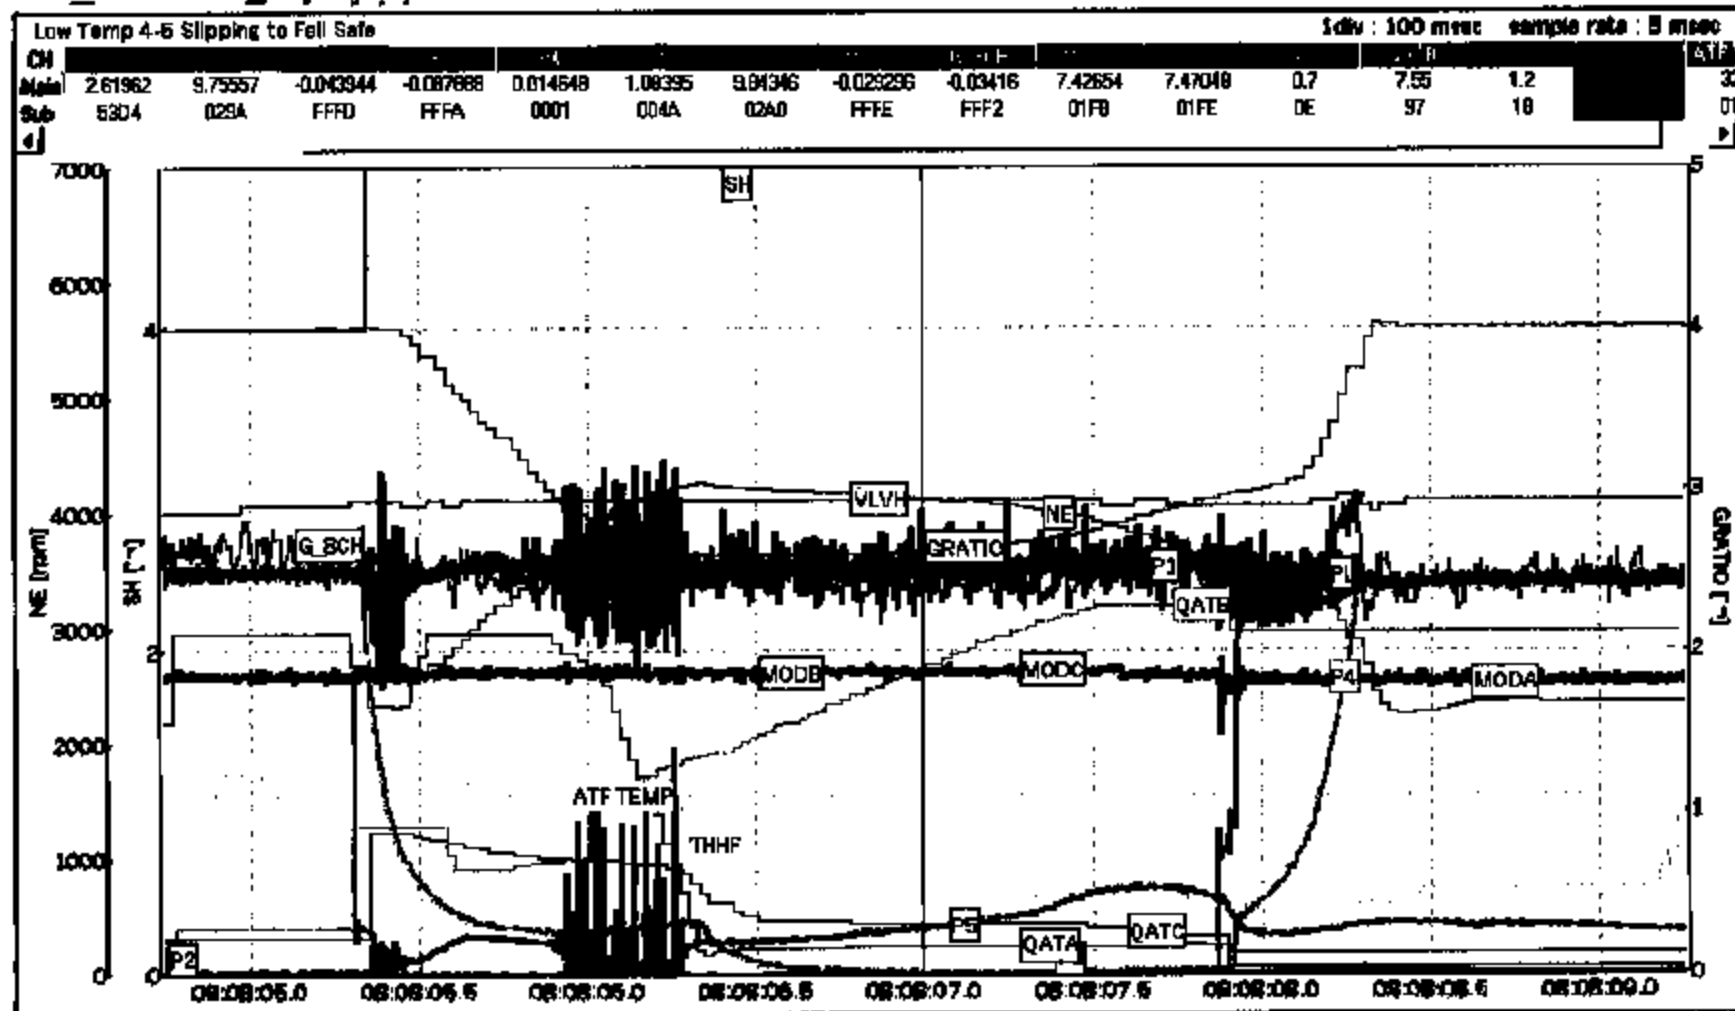
BGFA-1018818, Low Temperature Mode

During 4-5 shift major slipping occurred. ECU records shift time and G ratio, if abnormal shift time occurs and gear is not detected mission will shift to fail safe mode.

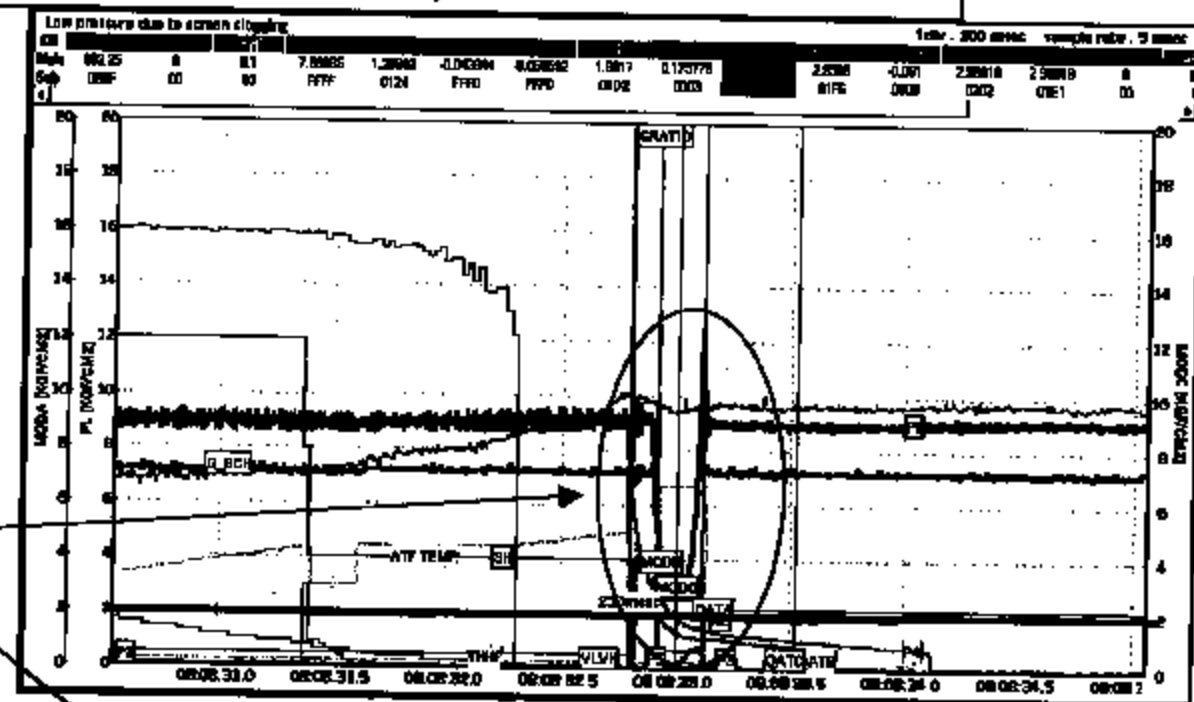
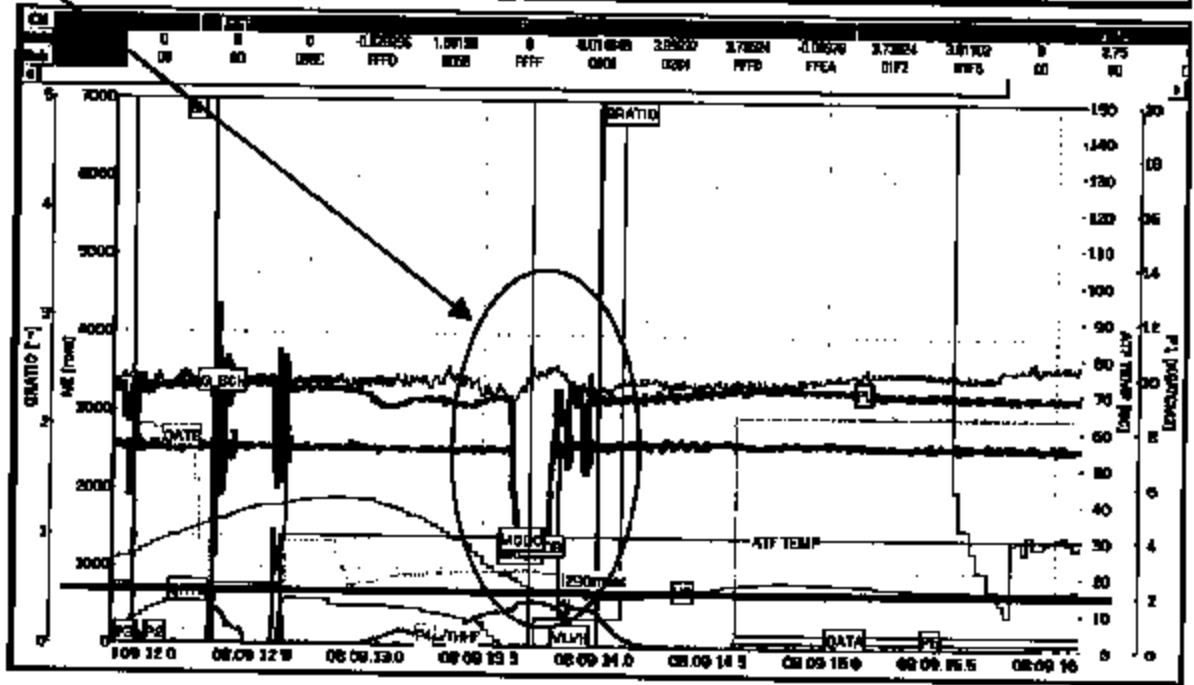
BGFA-1018818, Low Temperature Mode

Drop in total mission pressure due to screen clogging. Sudden Down shift didn't occur because Mod pressure was still above 2Kgf/Cm²

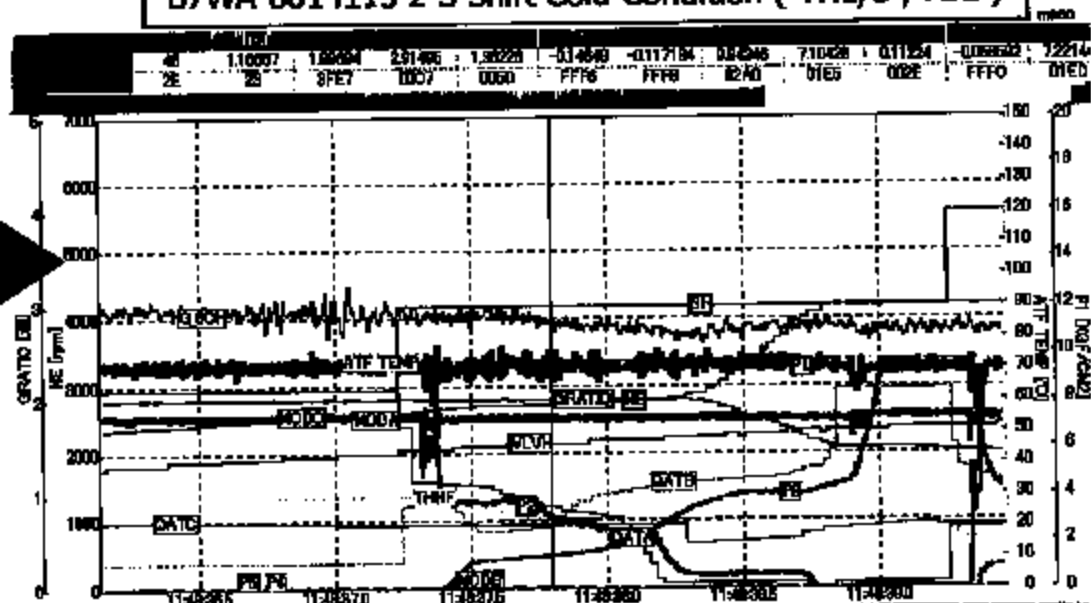
B7WA-8014113 2-3 Shift Cold Condition (TH1/8 , 72C)

2-3shift OK. Pressure OK.

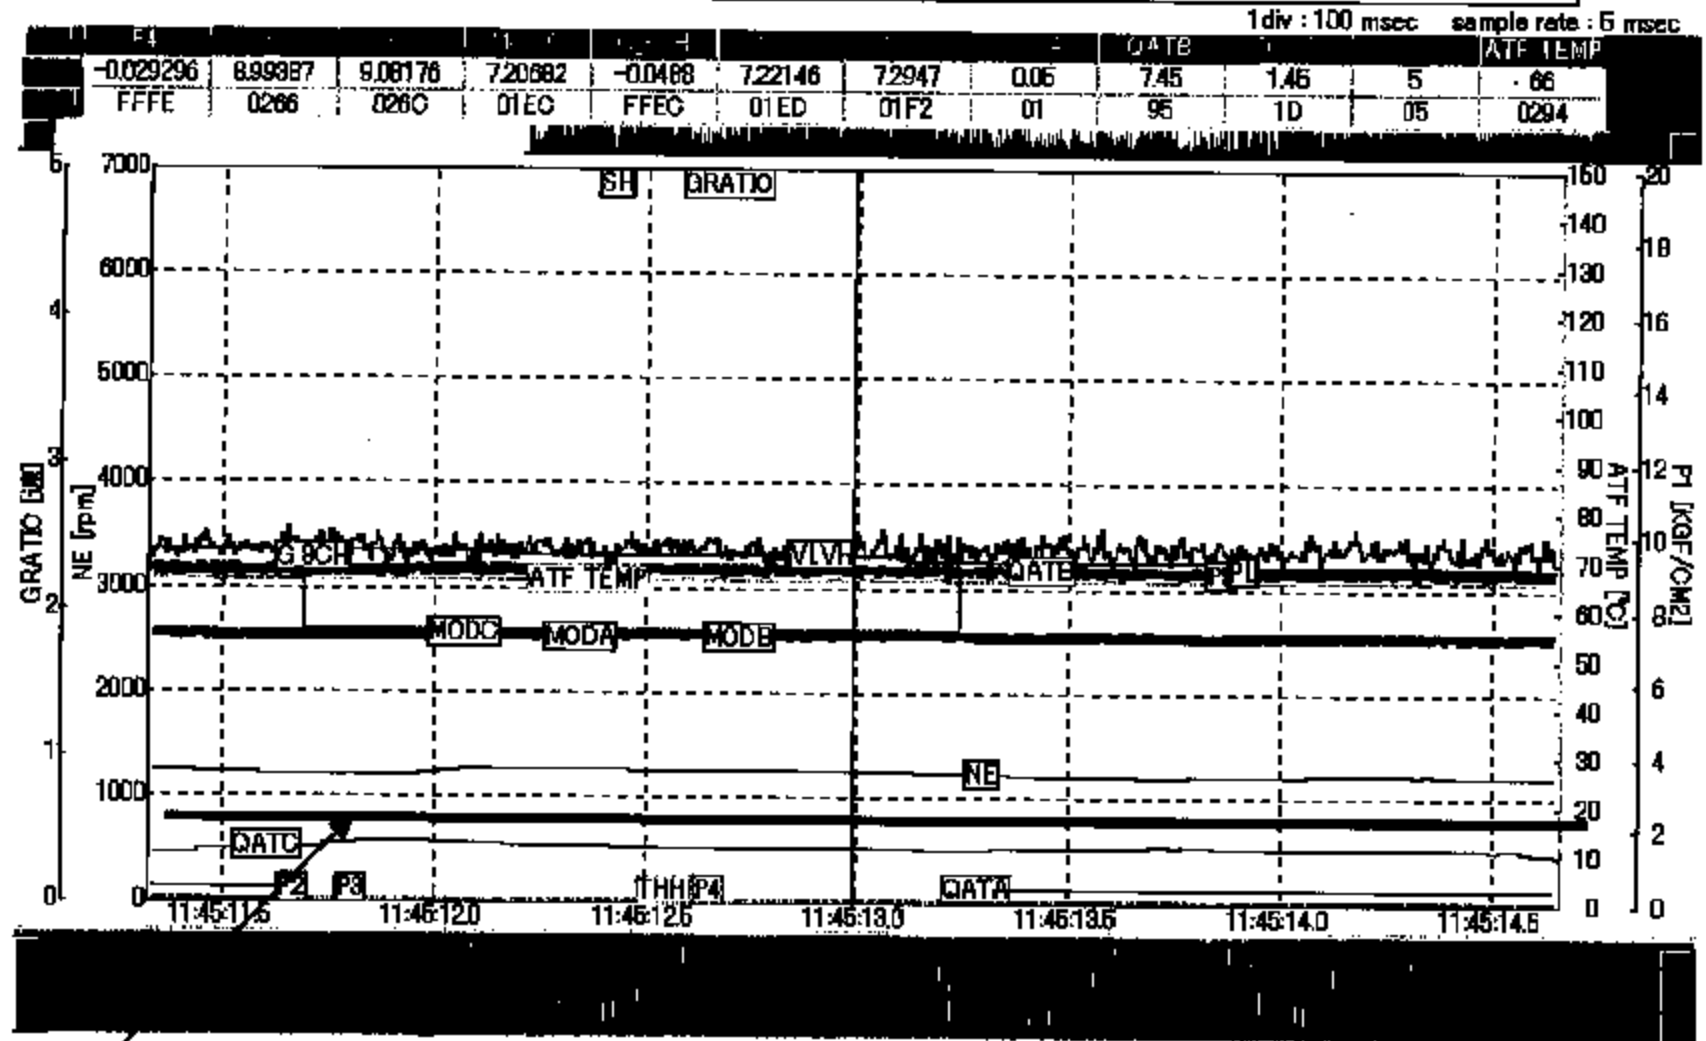
B7WA-8014113 5th cruise Cold Condition (TH off , 66C)

MOD Pressure Failure Point; Where mod pressure is overcome by shift valve C spring pressure.

Sudden down shift didn't happen.

Modulator pressure did not fall below (2 KGF/Cm²). So sudden down shift is not a possibility on this transmission.

Modulator pressure was below normal but able to overcome spring pressure.

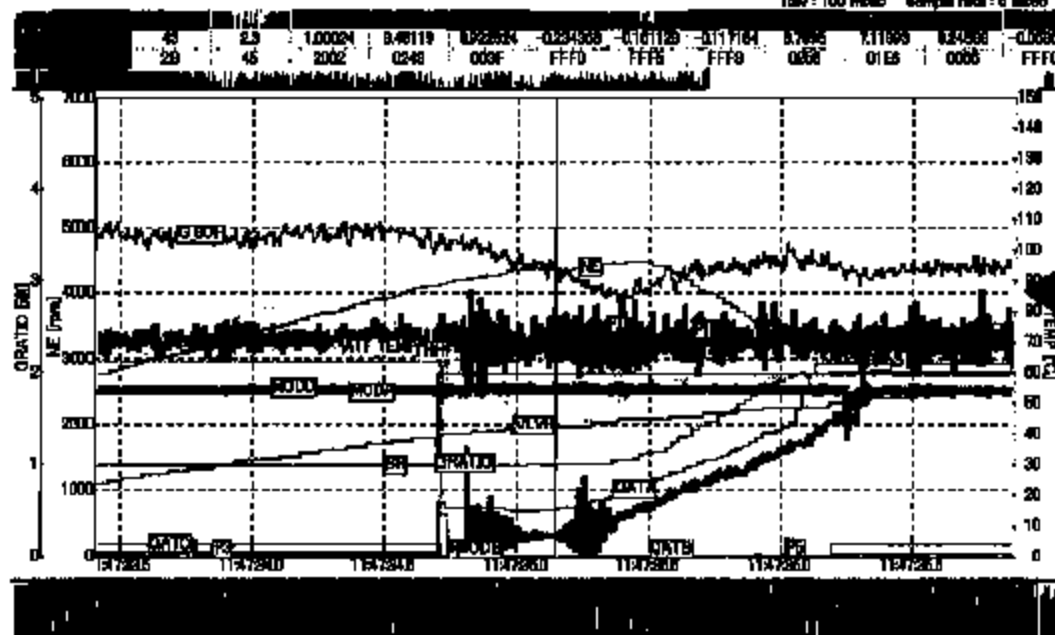
B7WA-8014113 1-2 Shift Cold Condition (TH3/8 , 70C)

Line Pressure, 1st Clutch and 2nd Clutch Pressure are Ok. (The cause vibrated line pressure is guessed noise.)

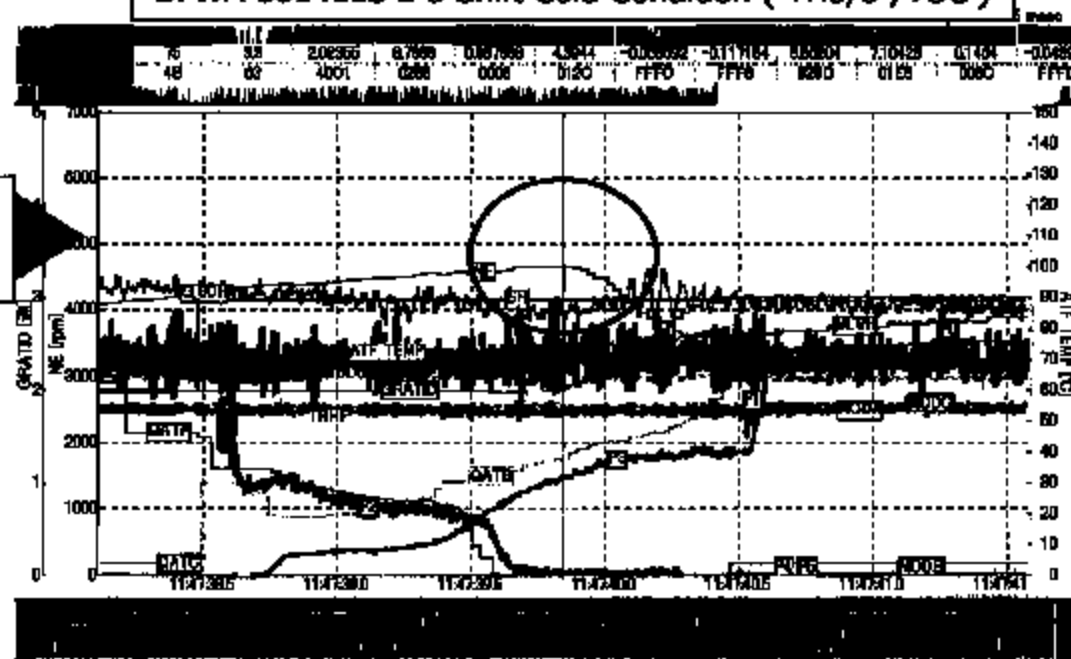
B7WA-8014113 2-3 Shift Cold Condition (TH3/8 , 73C)

Slipping found in 3rd Gear on 2-3 up shift.

2-3 shift slipping occurred . But it is possible to shift .

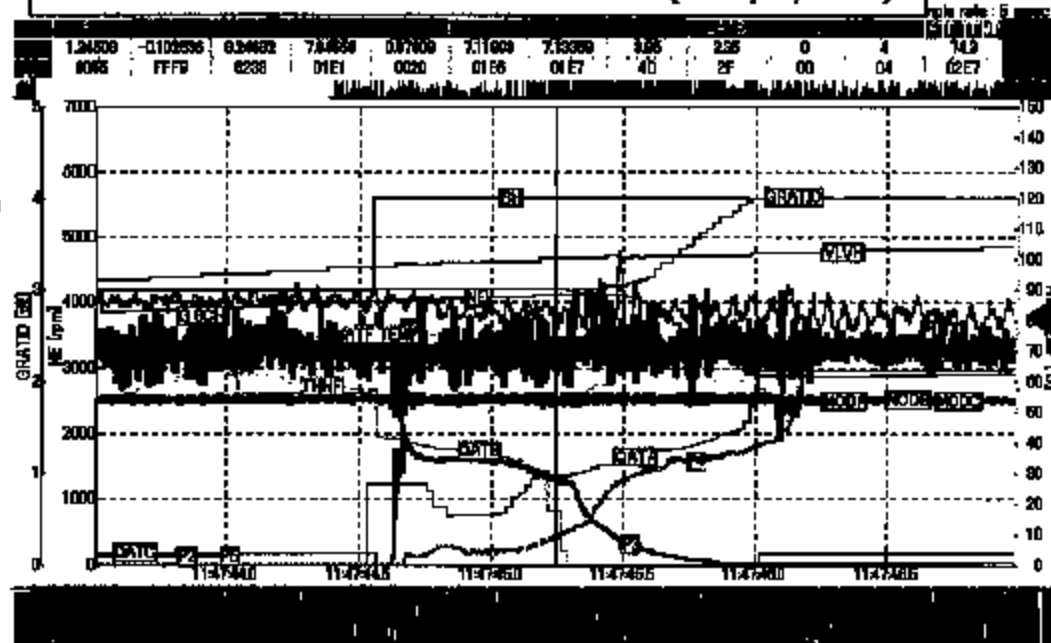
B7WA-8014113 3-4 Shift Cold Condition (TH3/8 , 73C)

3-4shift OK. Pressure OK.

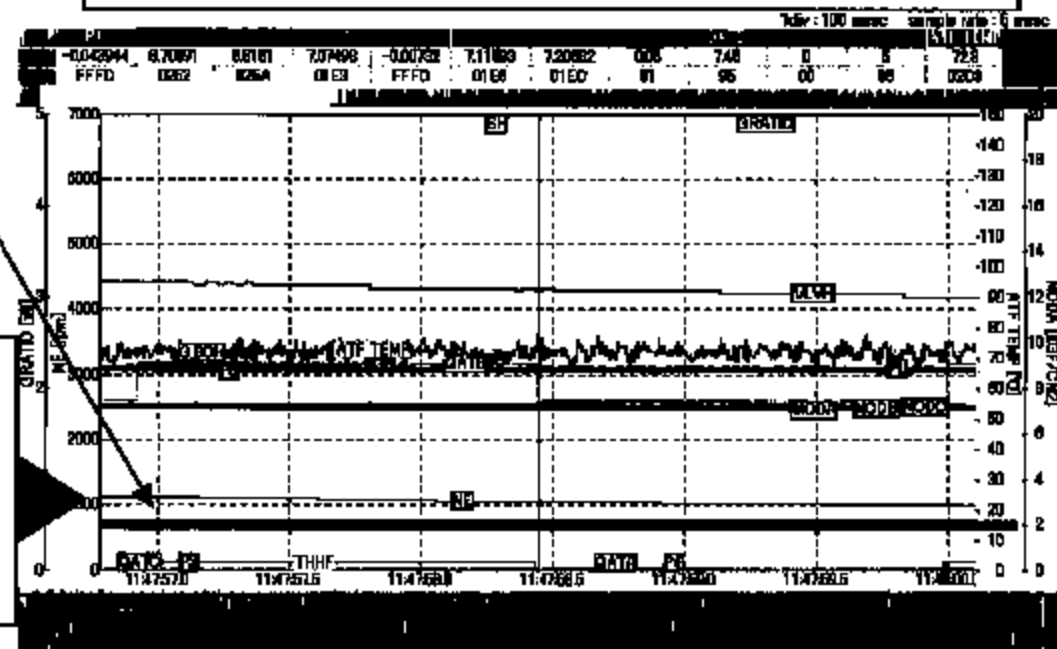
B7WA-8014113 5th cruse Cold Condition (TH off , 72C)

MOD Pressure Failure Point;
Where mod pressure is
overcome by shift valve C spring
pressure.

Sudden down shift didn't happen.
Modulator pressure did not fall below (2 KGF/Cm²).
So sudden down shift is not a possibility on this transmission. Modulator pressure was below normal but able to overcome spring pressure.

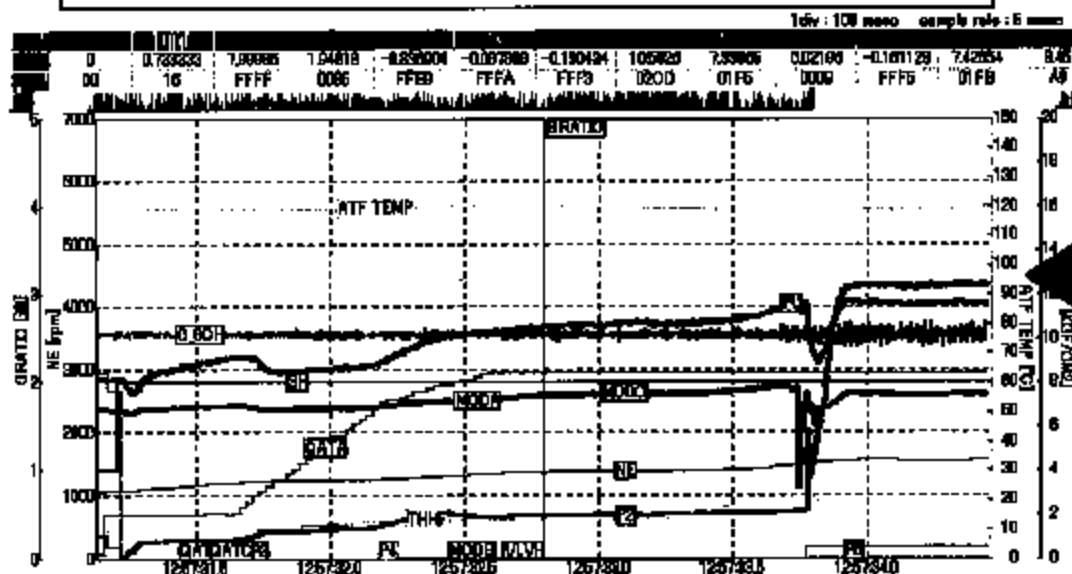
B7WA-8014113 1-2 Shift HOT Condition (112C)

2nd clutch slipped for long time.

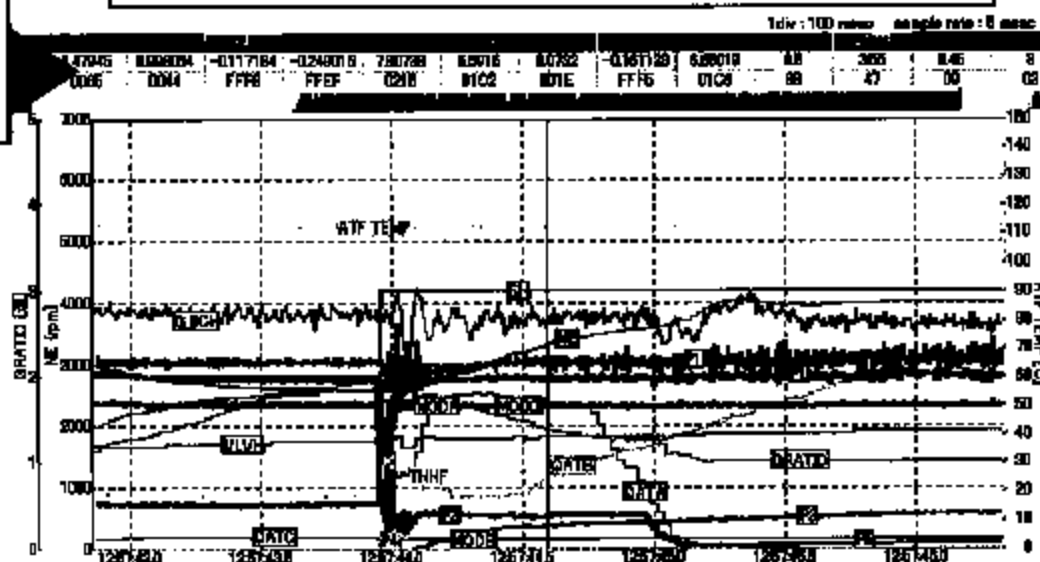
B7WA-8014113 2-3 Shift HOT Condition (120C)

Major slipping was noticed on 2-3 Up Shift.
2nd,3rd clutch pressure didn't increase.

It is impossible to shift normally. Mission entered fail safe mode soon after slipping.

Low clutch pressure is due to screen clogging, causing decrease in supply pressure from pressure sharing to other clutches.

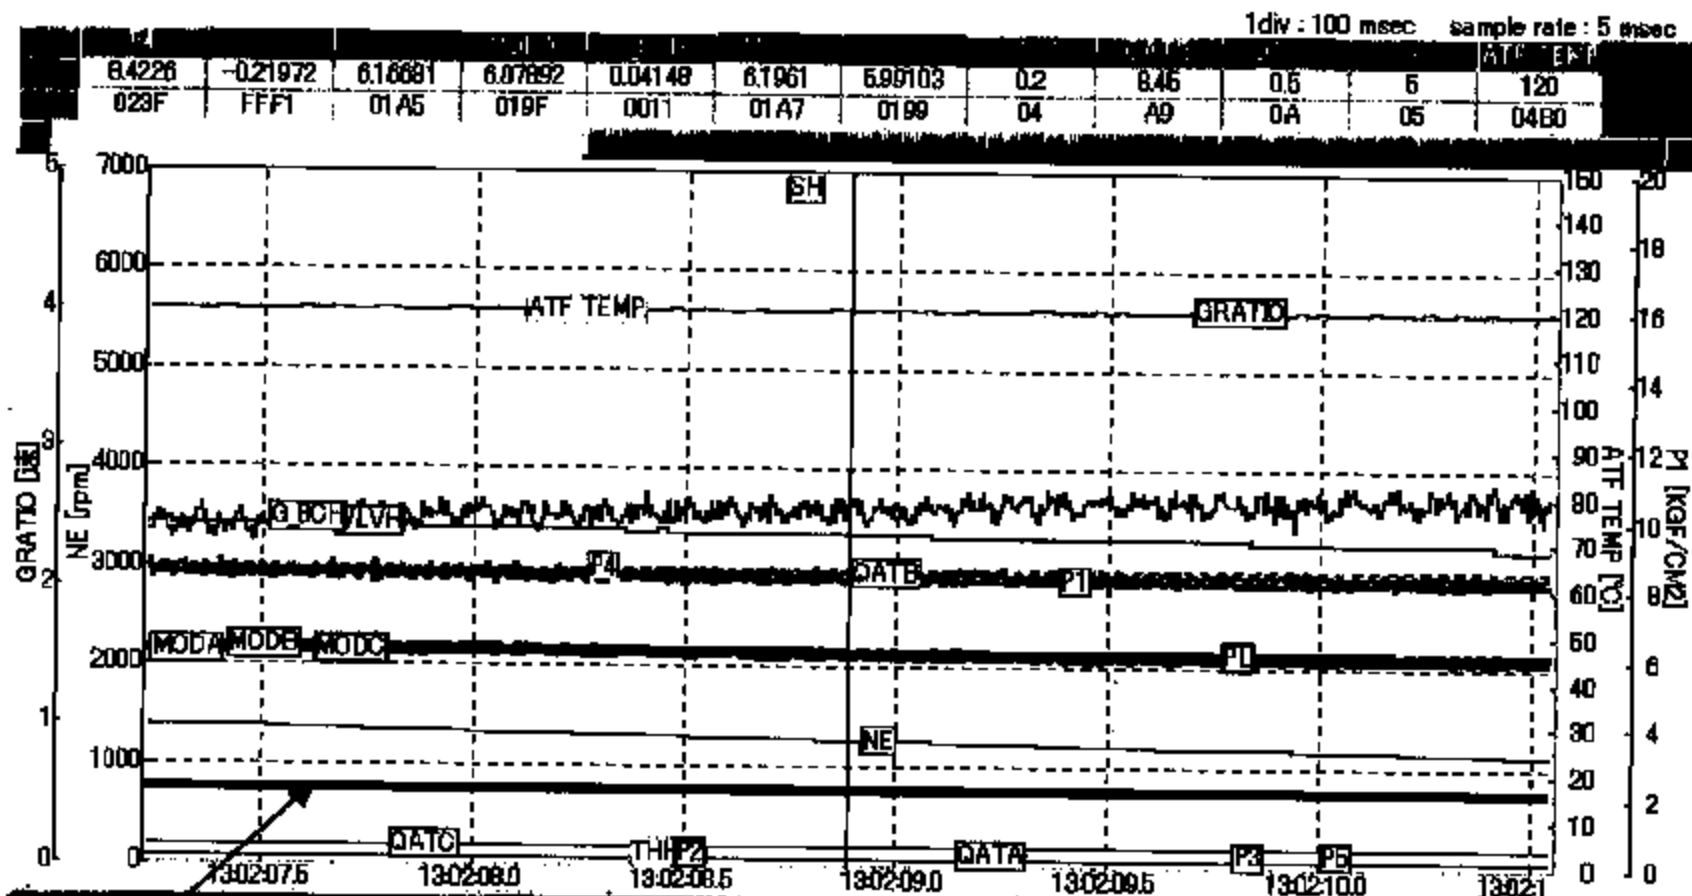
B7WA-8014113 fail mode(4TH) HOT Condition (112C)

MOD Pressure Failure Point;
Where mod pressure is
overcome by shift valve C spring
pressure.

Sudden down shift didn't happen.
Modulator pressure did not fall below (2 KGF/Cm²).
So sudden down shift is not a possibility on this
transmission. Modulator pressure was below
normal but able to overcome spring pressure.

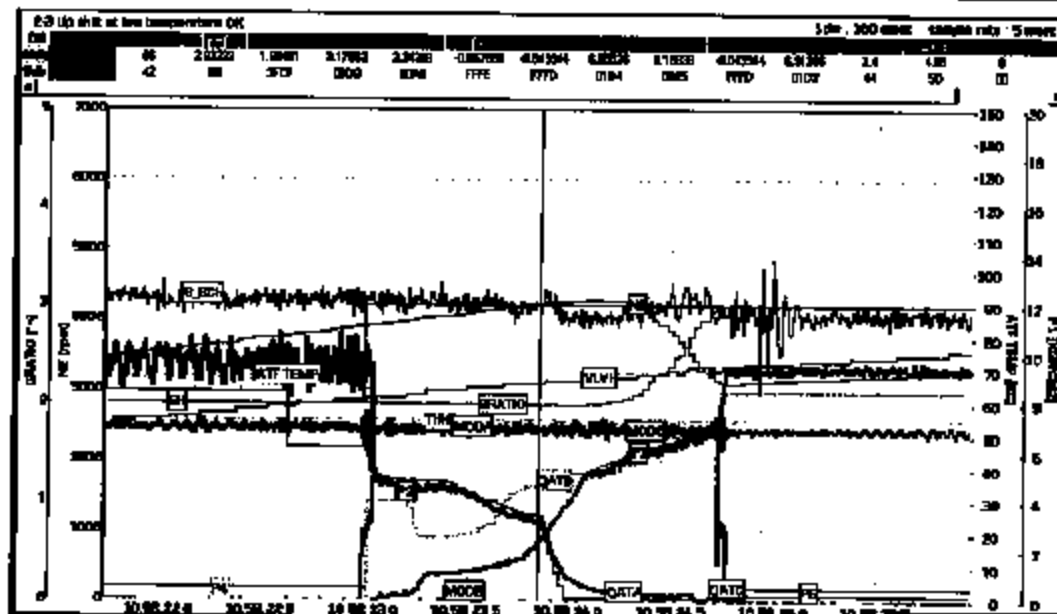
B7WA-8025514 Slipping found on 2-3 up shift at temp ~120 ° C

Major slipping was noticed on 2-3 Up Shift.
2nd,3rd clutch pressure didn't increase.

Line pressure and Modulator pressure
decreased due to screen clog.

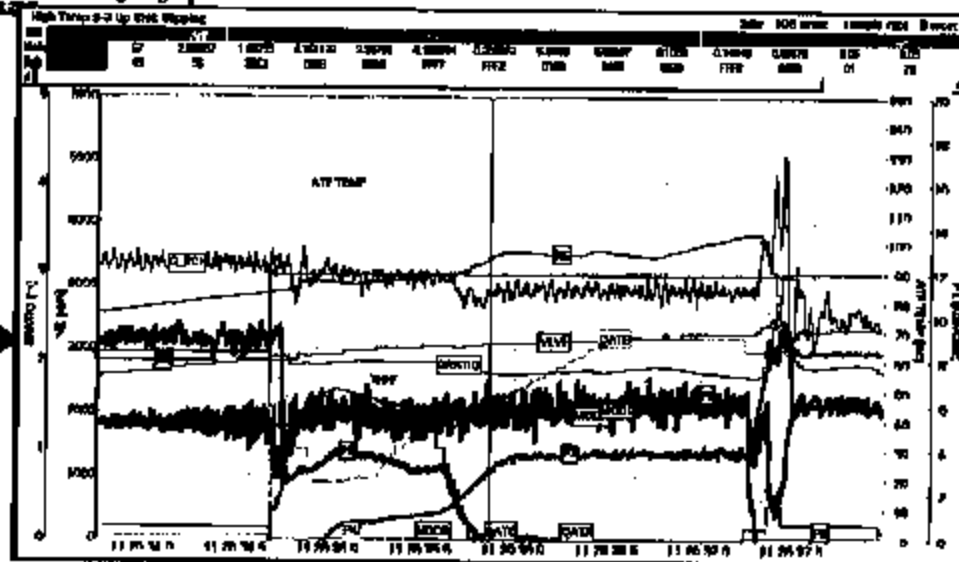
Slipping was found in 2-3 up shift. Unable to recreate sudden down shift contention. Low line pressure and modulator pressure due to screen clogging. (Line pressure is taken after screen)

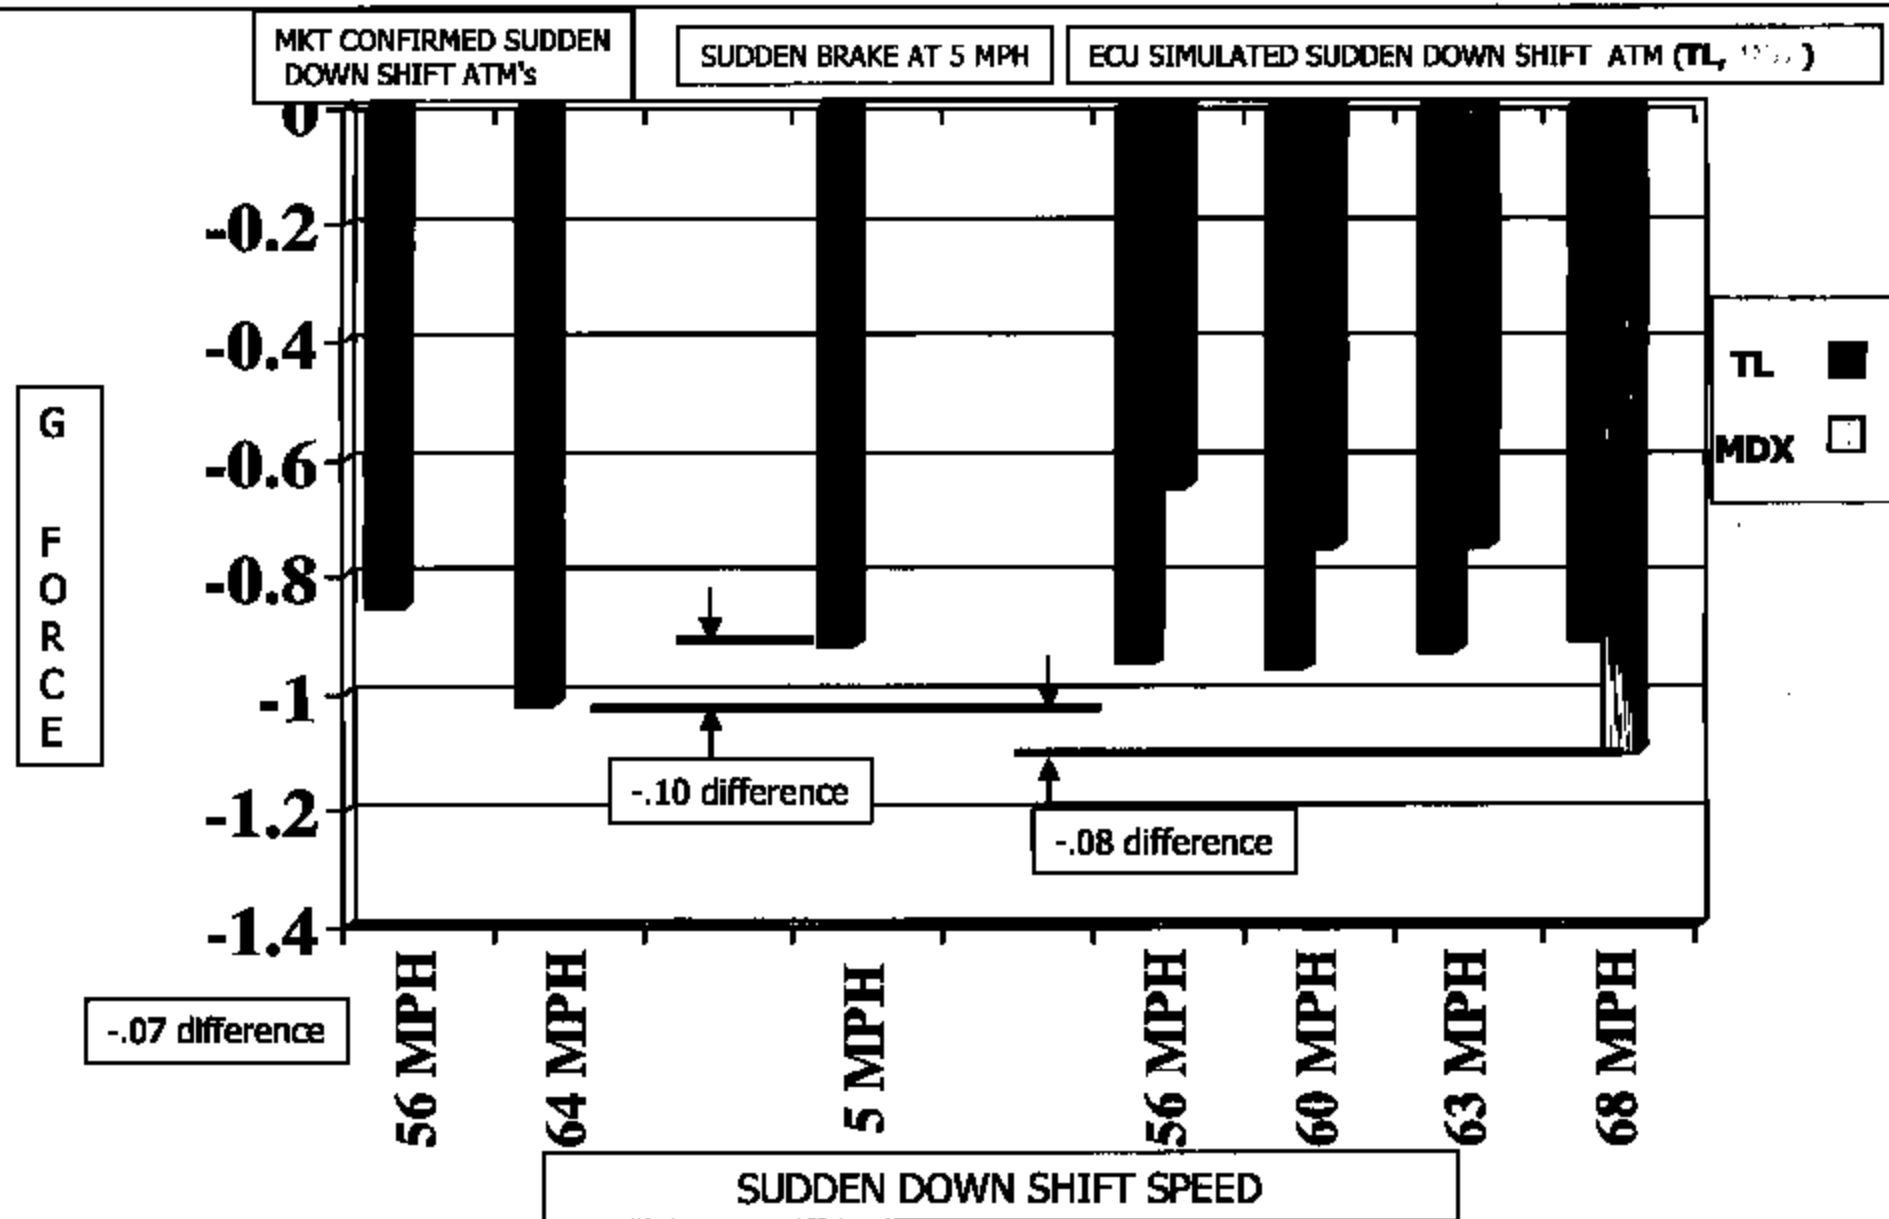
G FORCE COMPARISON BETWEEN MKT CONFIRMED AND ECU SIMULATED SUDDEN DOWN SHIFT MISSIONS

Worse case MKT failed mission is ~ -.10 G greater than ECU simulated Sudden Down Shift. 5 MPH sudden braking is -.06 less than worse case MKT sudden down shift.

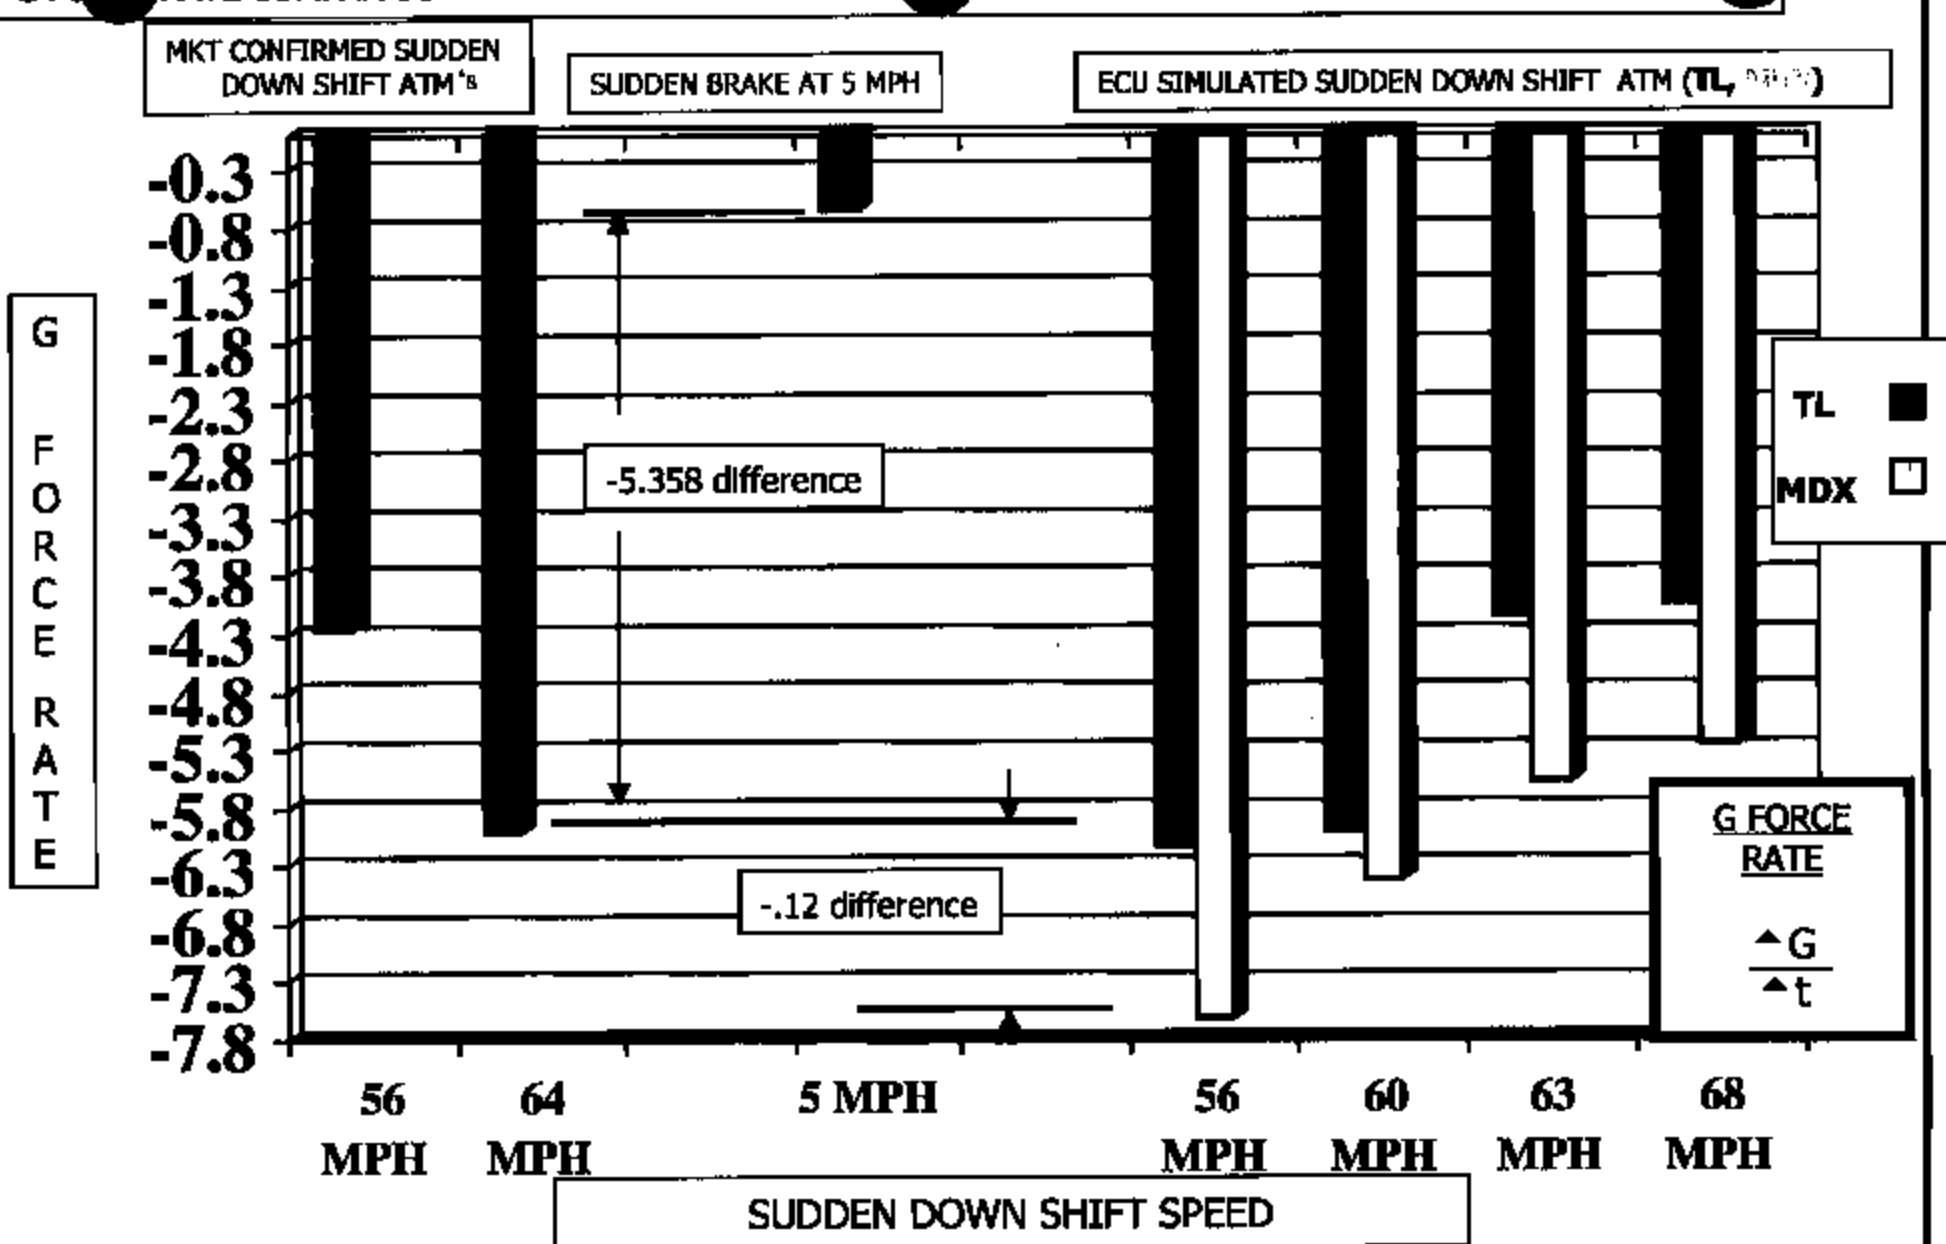
G FORCE RATE COMPARISON BETWEEN MKT CONFIRMED ECU SIMULATED SUDDEN DOWN SHIFT MISSION

Worse case MKT confirmed sudden down shift mission was -.12 G lower than worse case ECU simulated sudden down shift mission. Sudden brake at 5MPH was -5.358 less than worse case MKT Sudden down shift mission.

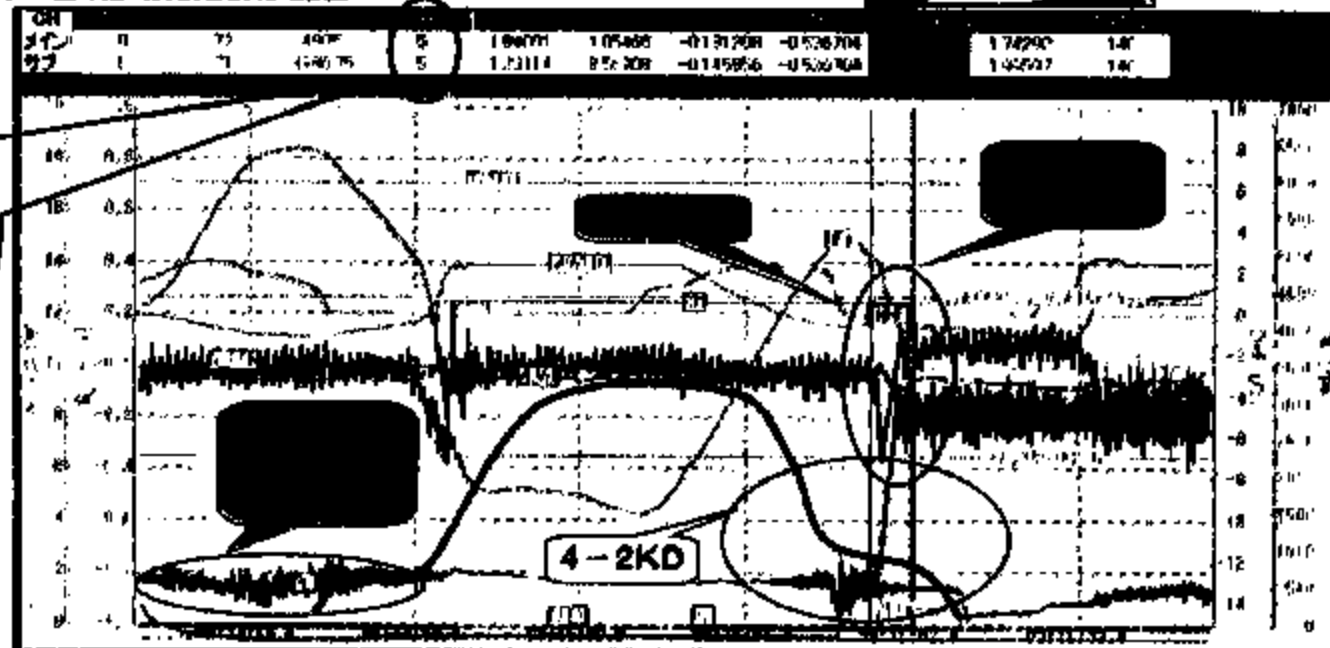
ECU Shift Signal
is Position 5
while mission
engages 4-2 KD.
This action is
Characteristic of
fail safe mode.

※ 4-2 KD are generated by the PL(MOD) pressure decrease,
the shift shock of 0.8G is generated.

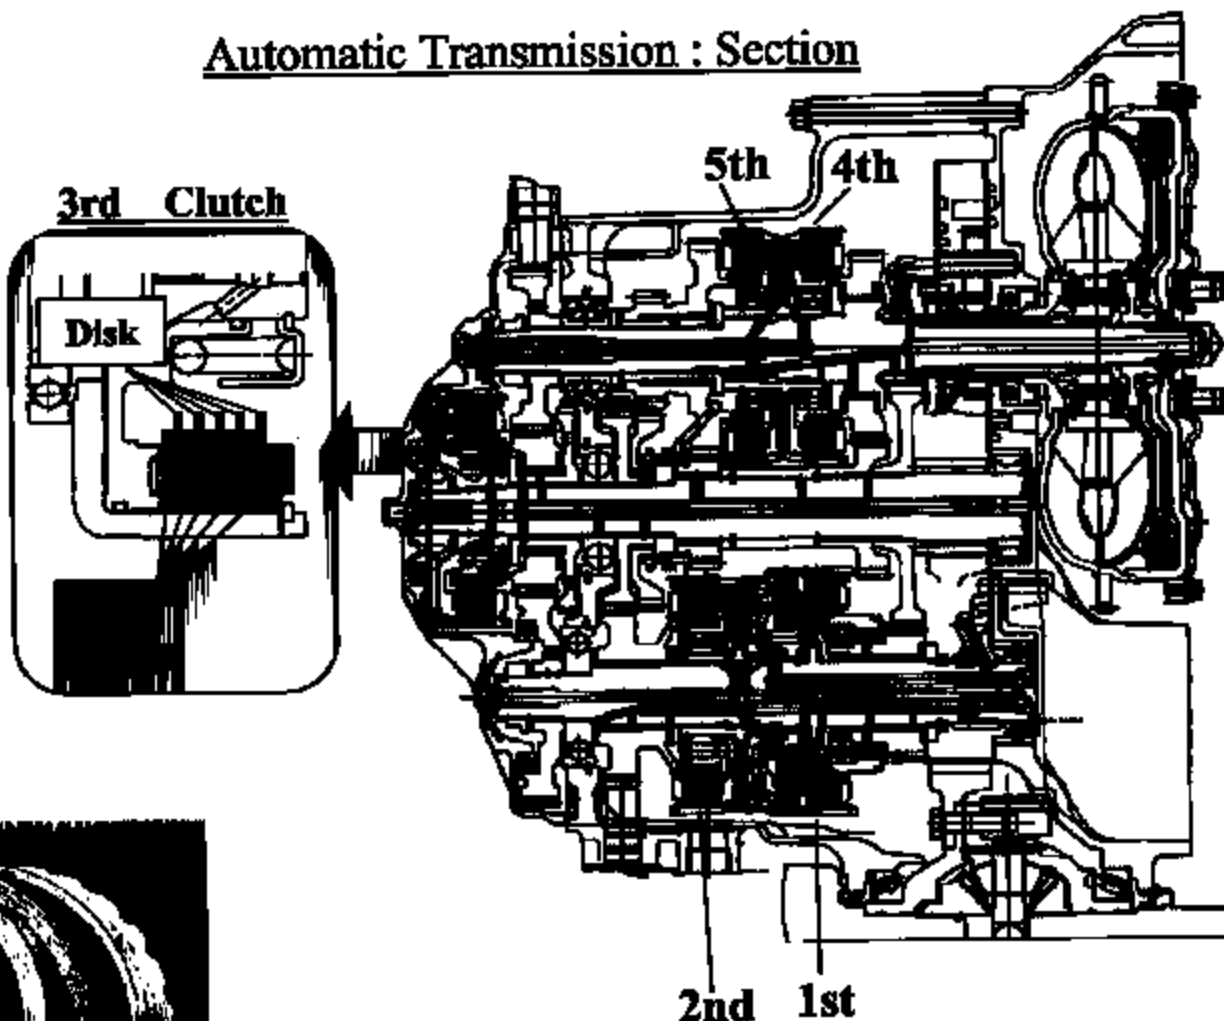
Failed part (3rd clutch)

The disks are worn abnormally.
